Manhole Inspection Summary

Manhole # S33OO1008MH

Insp Date: **4/20/07 5:13 AM**

Location Address: **4501 CHARLES ST**

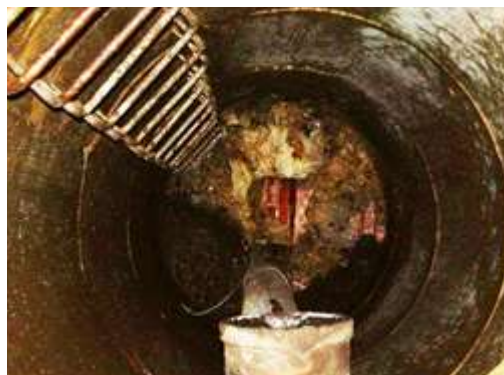
Top View

Bench ☒ Exists Material: **Brick** ☐ Parged ☒ **Debris** (not Condition related)

Condition: ☐ Sound ☐ Cracked ☐ Root Intrusion ☐ Deteriorated ☐ Leaks ☒ **Debris**

Bench and Channel debris.

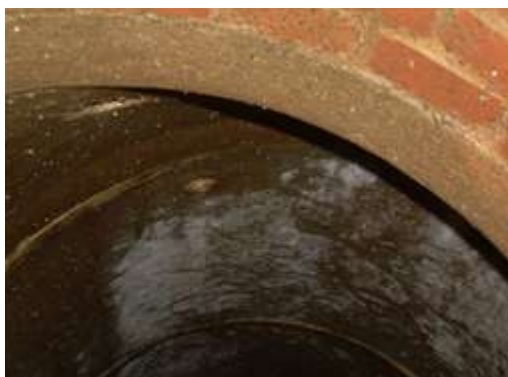
Defect

Infiltration: ☐ None ☒ **Joint** ☐ Cracks ☐ Mortar ☐ Roots ☒ **Wall**

Adjustment, Corbel, and Barrel infiltration.

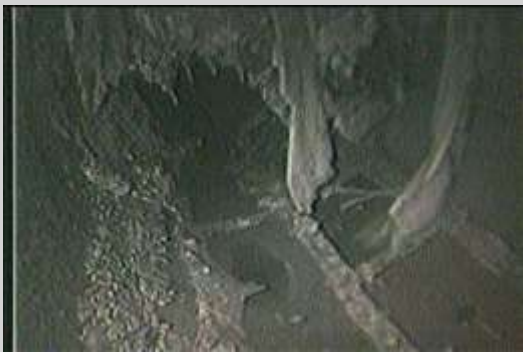
8 in. Circular Gravity Sewer Pipe Out @ 12 O'Clock

Deposits: ☐ None ☐ Mud ☐ Sludge ☐ Debris ☒ Grease

Silt Depth: **0** (in.) Deposits Extent: **Light**
